Property Access Checklist

Property ID: 3270	<input type="checkbox"/> WORK STARTED	ON: <u> </u> / <u> </u> / <u> </u>
Property Address: 4710 Elizabeth	<input type="checkbox"/> WORK COMPLETED	ON: <u> </u> / <u> </u> / <u> </u>

**U.S. Environmental Protection Agency
Vasquez Boulevard I/70 Superfund Site
Replacement Certificate**

4710 Elizabeth St.

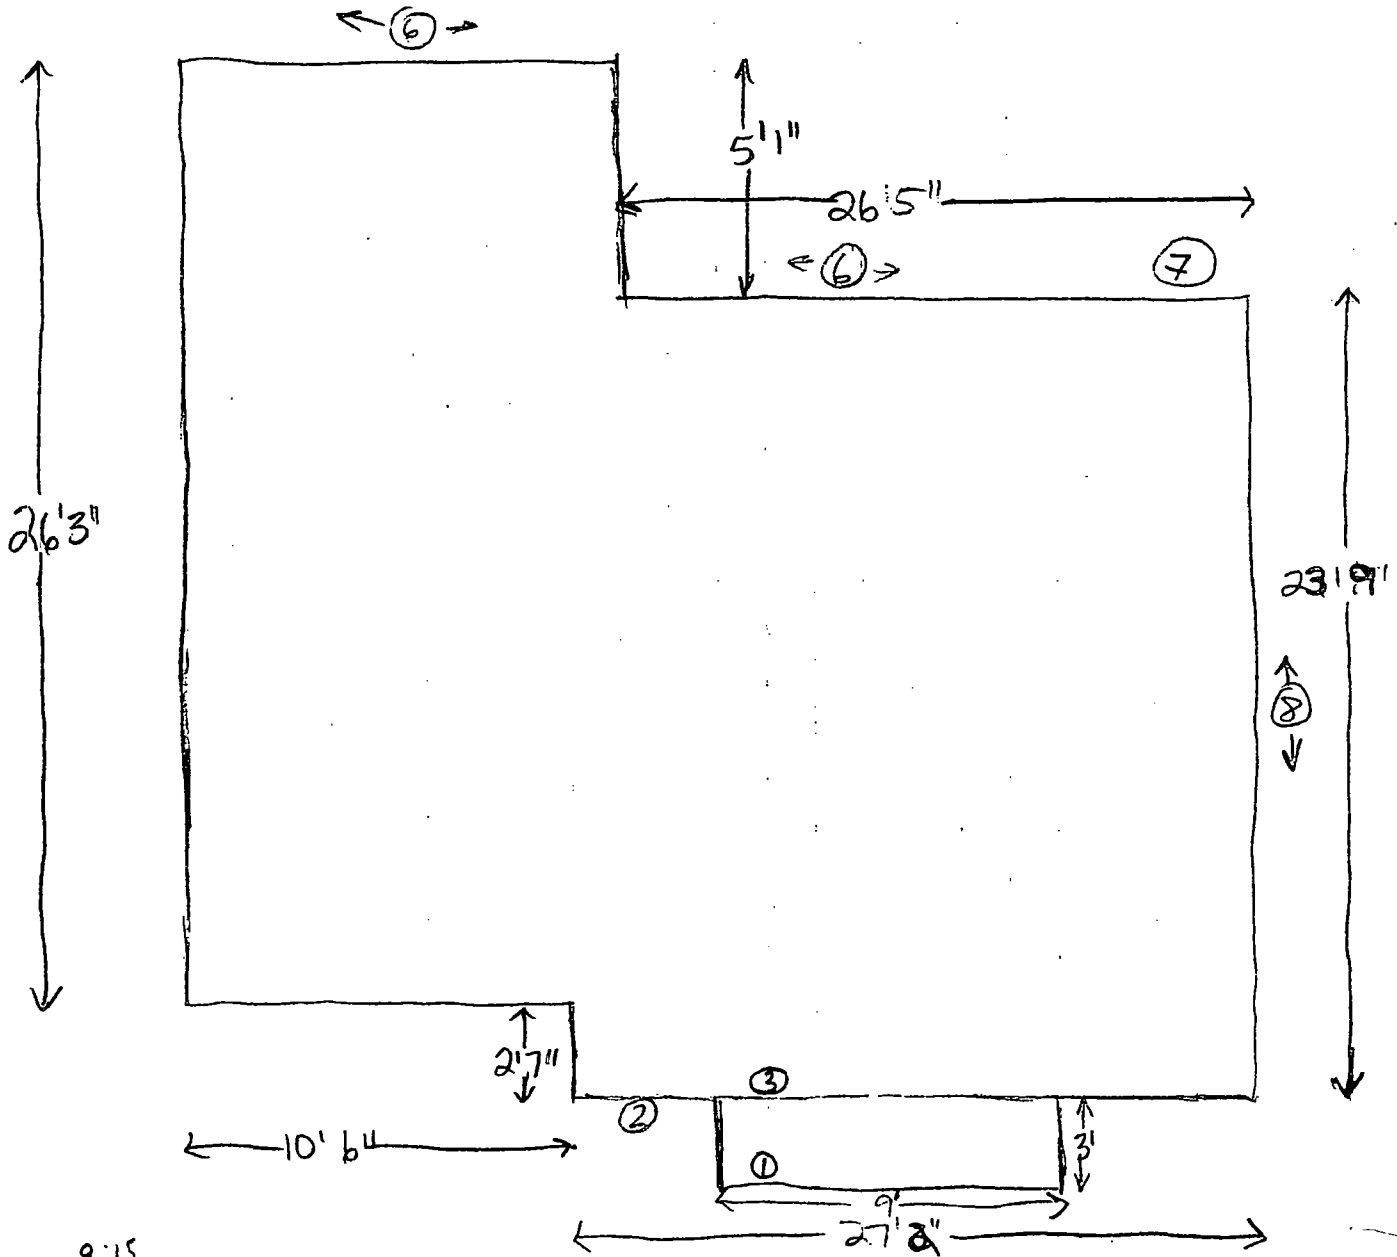
4710 Elizabeth St

Drawing Number	Photo Number	Painted Surface	Material	Color	Total Area of Element (units ft ²)	Percent Deteriorated	Deteriorated Area (units ft ²)	XRF #	XRF Value	pos/n
1	1-2	Front Porch Post	Wood	White	19.56	20%	3.91	282	4.9±1.9	POS
3	1-2	Front Door Threshold	Wood	White	N/A	N/A	0.88	283	0.1±0.2	NEG
2	3	Front Window Fframe	Wood	White	N/A	N/A	1.28	289	4.7±1.6	POS
N/A	N/A	Wall	Wood	Gray	240.71	20%	48.14	288	4.2±1.6	POS
					Total Area		53.33			
Address: 4710 Elizabeth St.		Structure: House								
Date: 8/16/05		Direction: N								
Investigator: CM, WH										
Time Started: 11:00 A.M.

Drawing Number	Photo Number	Painted Surface	Material	Color	Total Area of Element (units ft ²)	Percent Deteriorated	Deteriorated Area (units ft ²)	XRF #	XRF Value	pos/n
4	4	Wall/Soffit/Rafter Tails	Wood	Tan	258.13	30%	77.44	284	5.12±2.0	POS
5	5	Window Frame/Screen Frame	Wood	White	N/A	N/A	0.51	285	2.7±2.4	POS
					Total Area		77.95			
Address: 4710 Elizabeth St.		Structure: House								
Date: 8/16/05		Direction: E								
Investigator: CM, WH										
Time Started: 11:00 A.M.

Drawing Number	Photo Number	Painted Surface	Material	Color	Total Area of Element (units ft ²)	Percent Deteriorated	Deteriorated Area (units ft ²)	XRF #	XRF Value	pos/n
6	6	Wall/Soffit/Rafter Tails	Wood	Tan	370.39	100%	370.39	286	3.9±1.3	POS
7-Jan	7-8	Window Sill	Wood	White	N/A	N/A	1.5	287	2.8±1.1	POS
					Total Area		371.89			
Address: 4710 Elizabeth St.		Structure: House								
Date: 8/16/05		Direction: S								
Investigator: CM, WH										
Time Started: 11:00 A.M.

Drawing Number	Photo Number	Painted Surface	Material	Color	Total Area of Element (units ft ²)	Percent Deteriorated	Deteriorated Area (units ft ²)	XRF #	XRF Value	pos/n
8	7-8	Wall/Soffit/Rafter Tails	Wood	Tan	283.53	50%	141.76	See 286	3.9±1.3	POS
					Total Area		141.76			
					Total for All		644.93

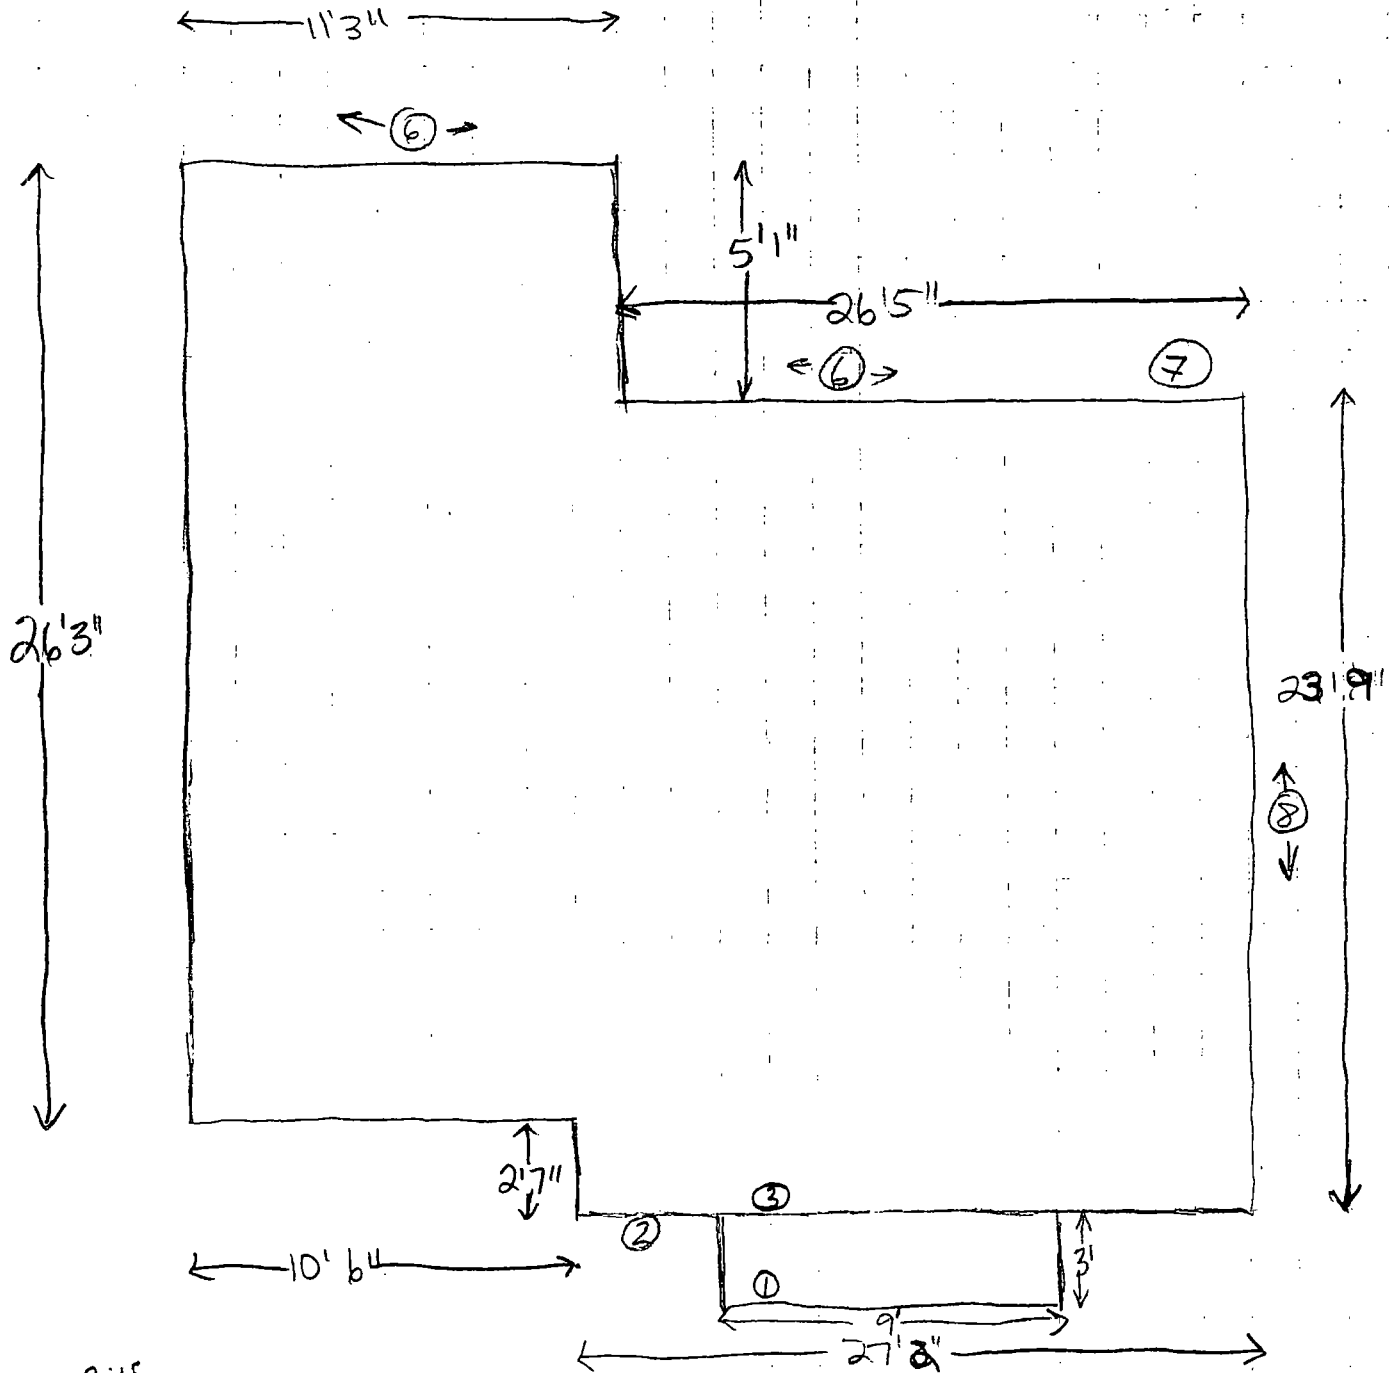
4710 Elizabeth St

Drawing Number	Photo Number	Painted Surface	Material	Color	Total Area of Element (units ft^2)	Percent Deteriorated	Deteriorated Area (units ft^2)	XRF #	XRF Value	pos/neg	Notes
1	1-2	Front Porch Post	Wood	White	19.56	20%	3.91	282	4.9±1.9	POS	
3	1-2	Front Door Threshold	Wood	White	N/A	N/A	0.88	283	0.1±0.2	NEG	
2	3	Front Window Frame	Wood	White	N/A	N/A	1.28	289	4.7±1.6	POS	
N/A	N/A	Wall	Wood	Gray	240.71	20%	48.14	288	4.2±1.6	POS	
					Total Area		53.33				
Address: 4710 Elizabeth St.		Structure: House									
Date: 8/16/05		Direction: N									
Investigator: CM, WH											
Time Started: 11:00 A.M.

Drawing Number	Photo Number	Painted Surface	Material	Color	Total Area of Element (units ft^2)	Percent Deteriorated	Deteriorated Area (units ft^2)	XRF #	XRF Value	pos/neg	Notes
4	4	Wall/Soffit/Rafter Tails	Wood	Tan	258.13	30%	77.44	284	5.12±2.0	POS	
5	5	Window Frame/Screen Frame	Wood	White	N/A	N/A	0.51	285	2.7±2.4	POS	
					Total Area		77.95				
Address: 4710 Elizabeth St.		Structure: House									
Date: 8/16/05		Direction: E									
Investigator: CM, WH											
Time Started: 11:00 A.M.

Drawing Number	Photo Number	Painted Surface	Material	Color	Total Area of Element (units ft^2)	Percent Deteriorated	Deteriorated Area (units ft^2)	XRF #	XRF Value	pos/neg	Notes
6	6	Wall/Soffit/Rafter Tails	Wood	Tan	370.39	100%	370.39	286	3.9±1.3	POS	
7-Jan	7-8	Window Sill	Wood	White	N/A	N/A	1.5	287	2.8±1.1	POS	
					Total Area		371.89				
Address: 4710 Elizabeth St.		Structure: House									
Date: 8/16/05		Direction: S									
Investigator: CM, WH											
Time Started: 11:00 A.M.
